LEVEL 1 INSPECTION & TESTING

SAVANA ESTATE, STAGE 3, WYNDHAM VALE

Prepared for Bitu-Mill Civil Pty Ltd

Report Reference: GS4505.2 AA

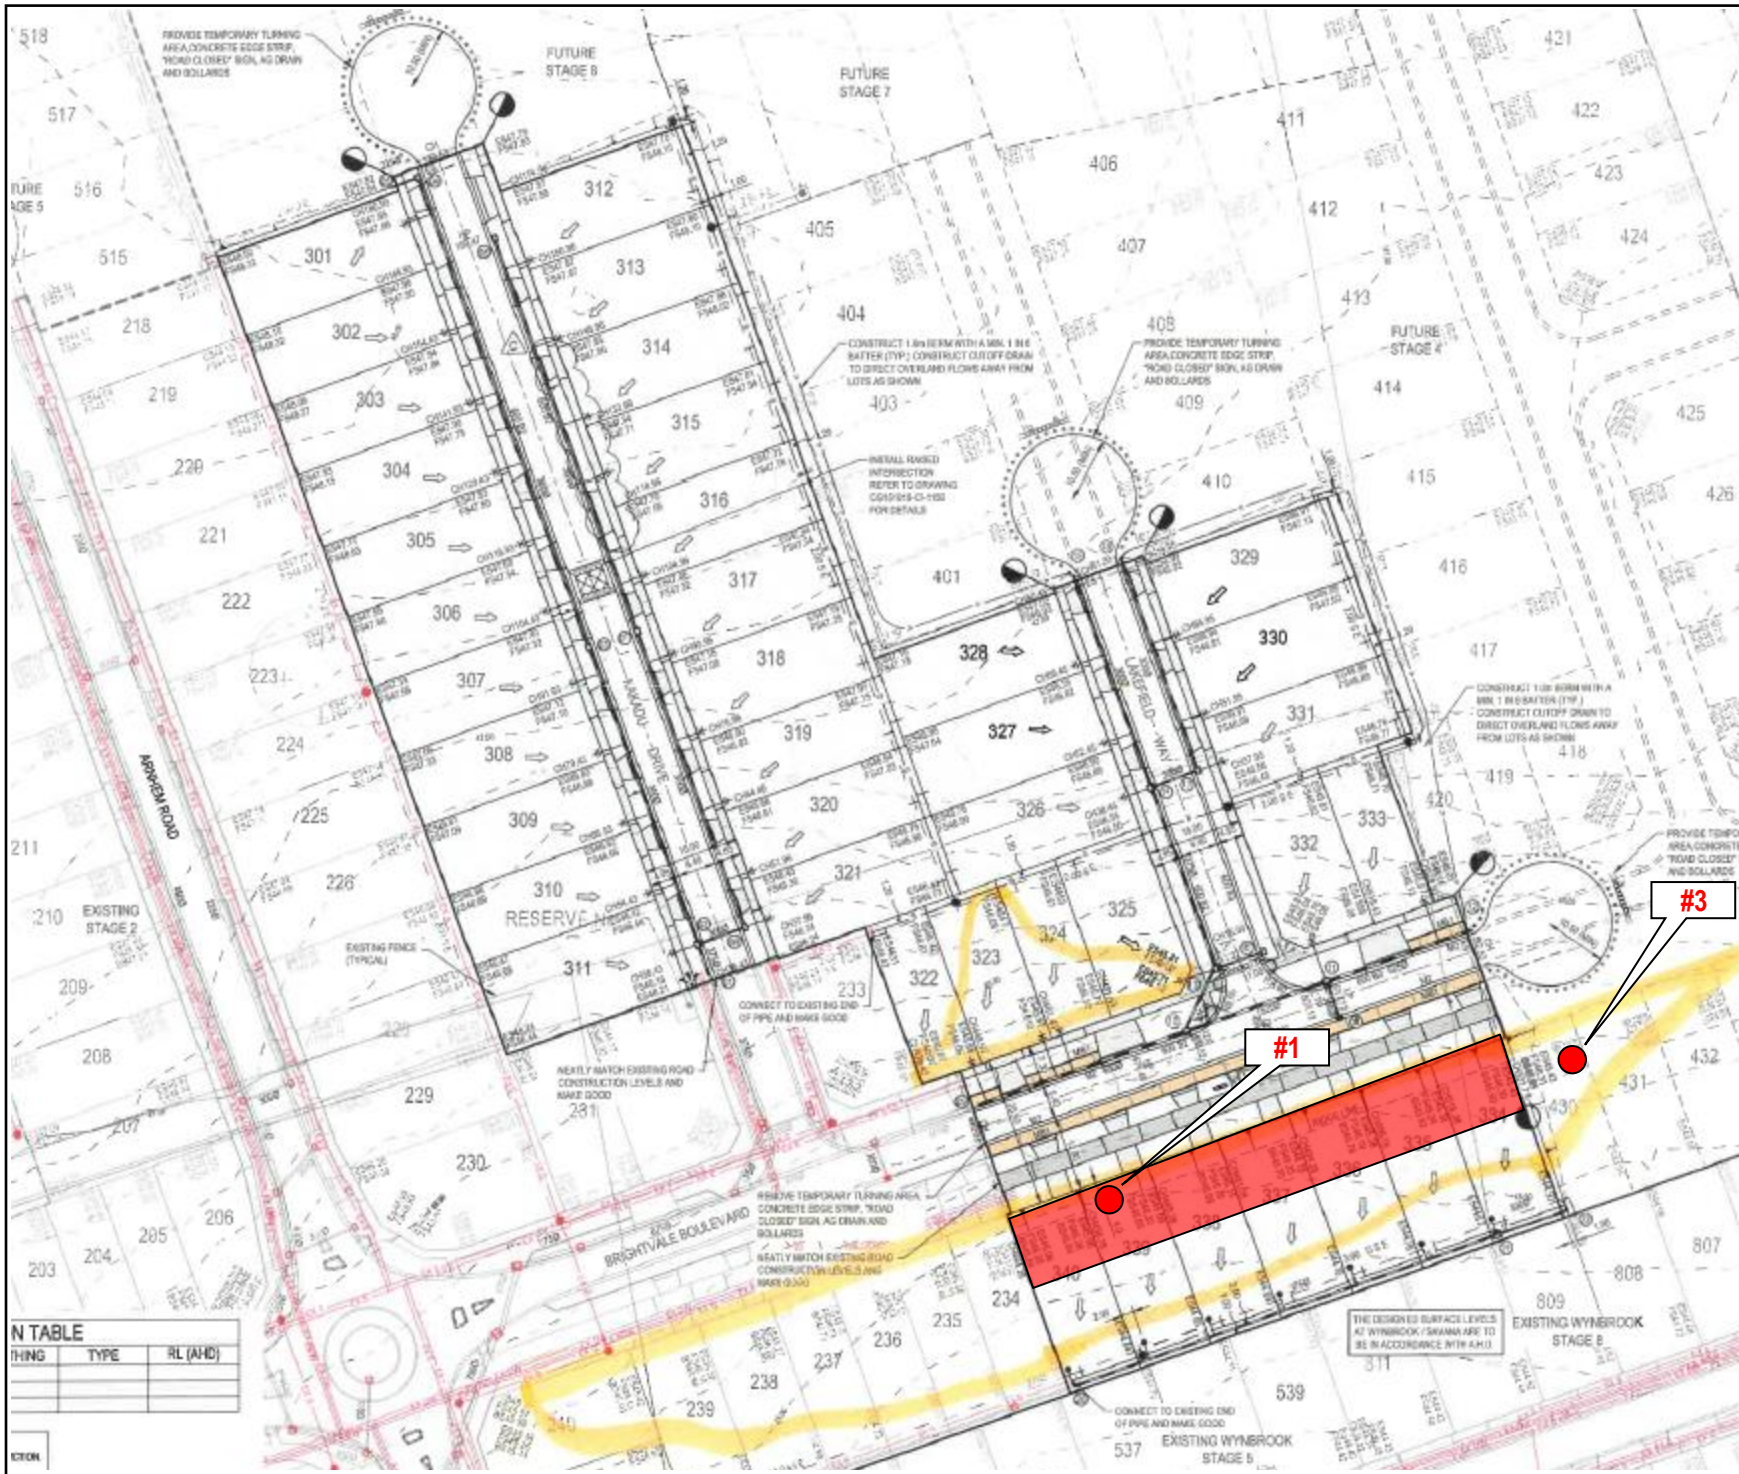
FIGURE 1

All tests achieved the target density ratio of 95% Standard Compaction. The moisture conditioning was found to be within the recommended moisture ratio of 85% to 115% within tests #2 and #3. A moisture ratio of 83% was achieved in Test #1 however deemed acceptable, with instructions provided to further moisture condition the material on site. Retesting was not deemed necessary.

Note: Test #3 performed on Stage 4 (Refer to GS4505.3)
