# **LEVEL 1 INSPECTION & TESTING**

## **SAVANA ESTATE, STAGE 2, WYNDHAM VALE**

**Report Reference: GS4505.1 AA**

**Date: 1 December 2017**

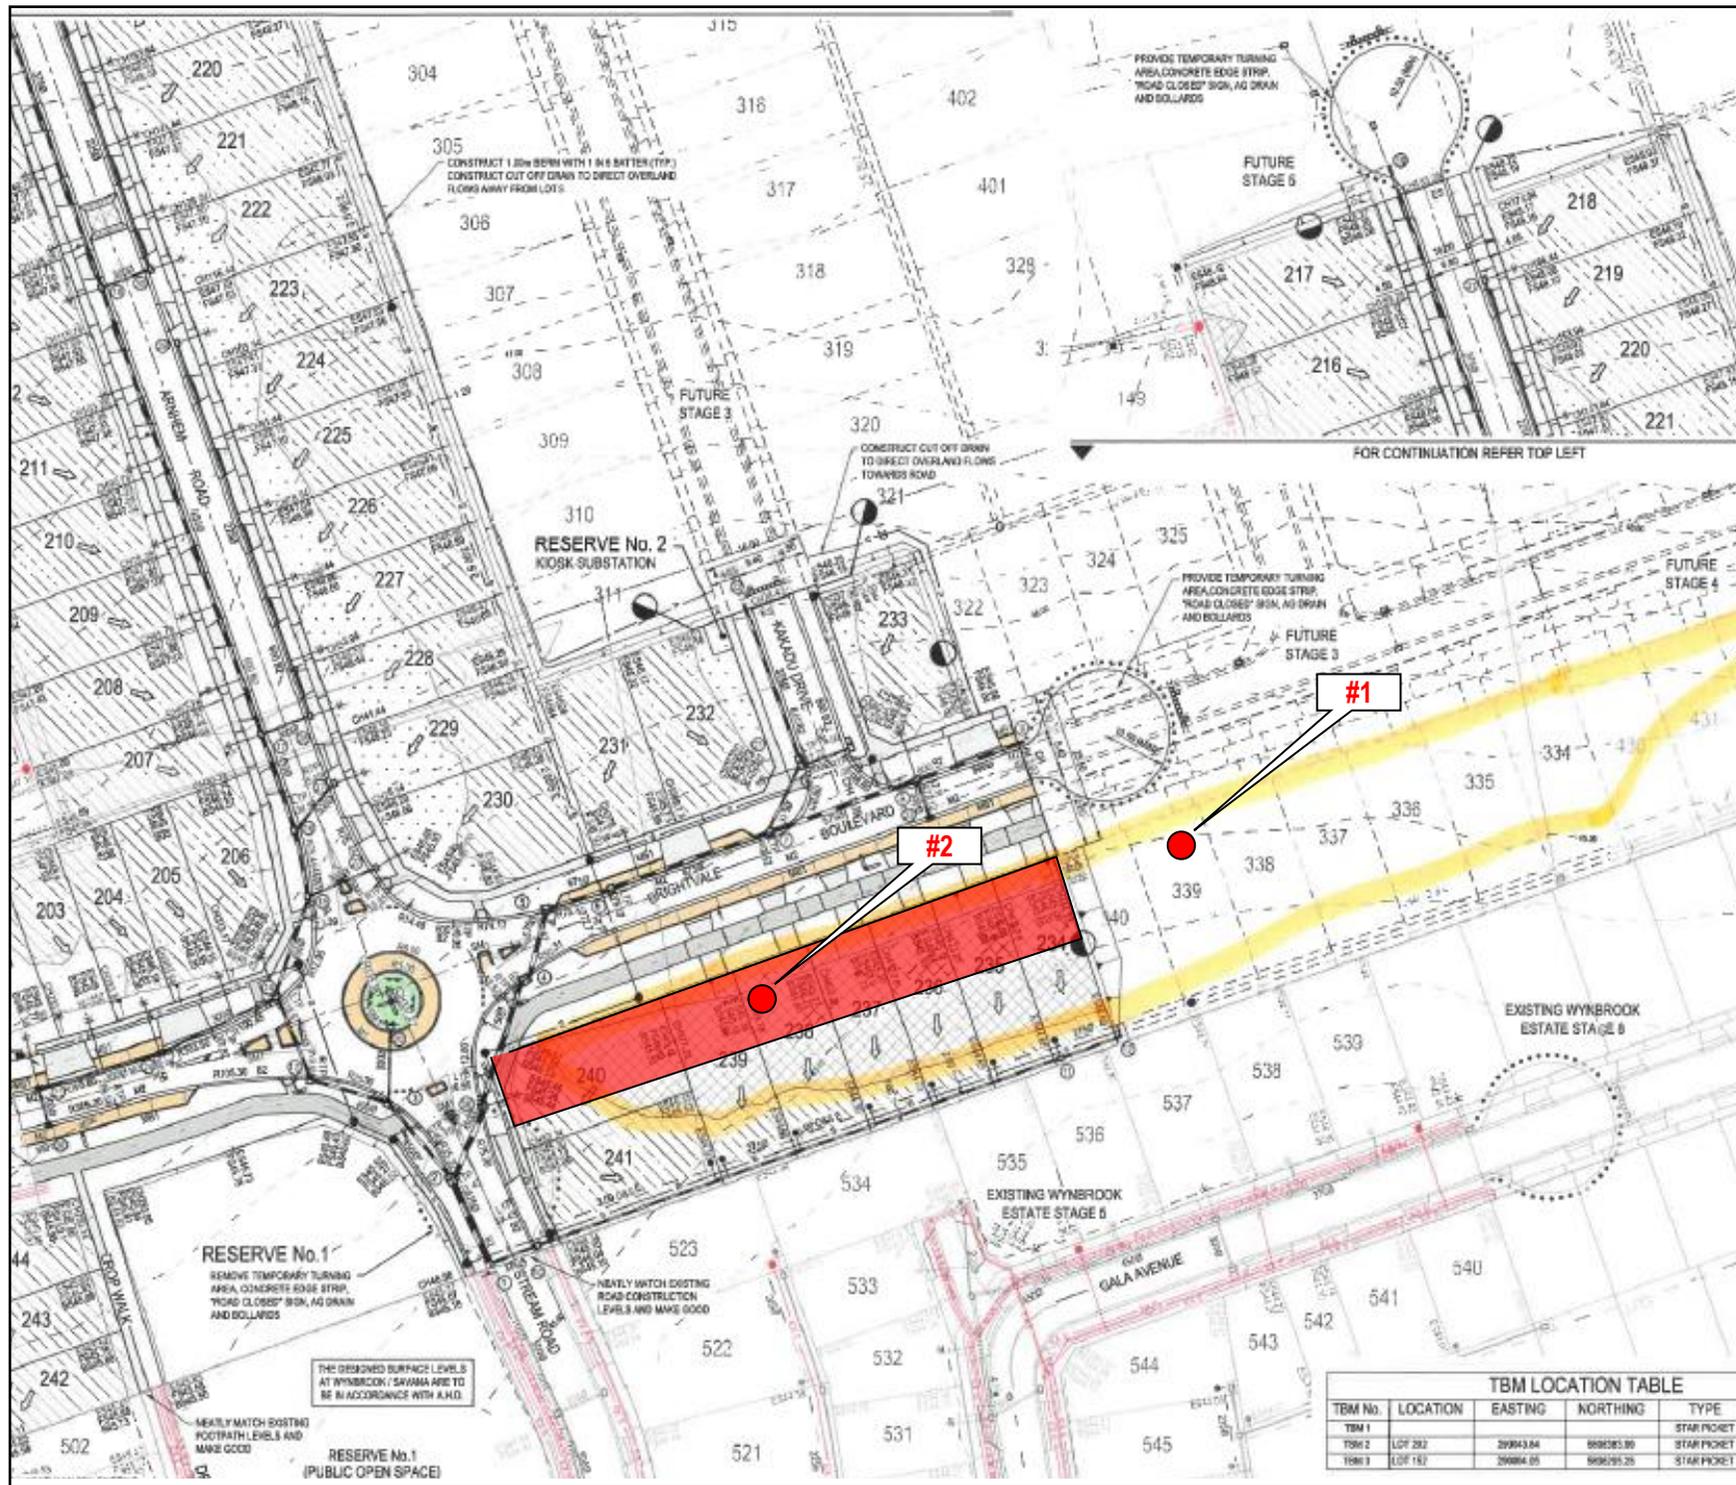
FIGURE 1

Savana Estate, Wyndham Vale  
Site and Test Location Plan

● Field Density Test

Note: Test #1 performed on Stage 3 (Refer to GS4505.2)
